Historic submergence and tsunami destruction of Nancowrie, Kamorta, Katchall and Trinket Islands of Nicobar district: Consequences of 26 December 2004 Sumatra–Andaman earthquake

M. G. Thakkar* and Bhanu Goyal

Department of Geology, R. R. Lalan College, Bhuj, Kachchh 370 001, India

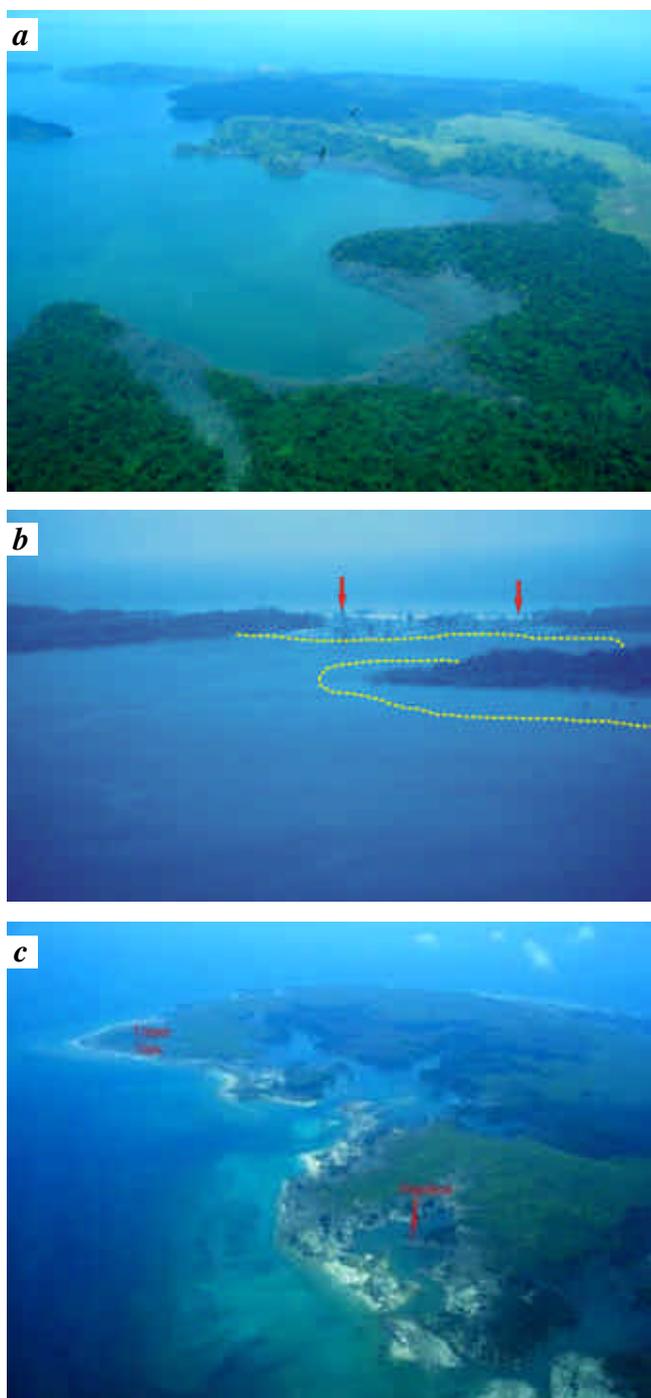
Figure 4. *a*, Aerial view of Kamorta Island. Dried coastal forests are seen in discernible grey colour along the shores of the Grand Harbour. *b*, Aerial view of Trinket Island. Arrows mark the sandbar bridge that connects southern and middle part of the island. The narrow strip of sand bar is 20–30 m in width shown closely in Figure 5 *e, f*. Yellow lines indicate previous coast line. *c*, Aerial view of northern part of Kamorta Island distinctly showing coastal inundation in the creeks and submergence of sandy beaches in the western part. The flat land at Pillpillow is under the water, with most of the vegetation having been destroyed.

The pre- and post-earthquake satellite imageries and aerial photographs of Kamorta, Nancowrie, Katchall and Trinket Islands show coastal inundation and drying-up of

coastal mangroves and tropical forests (Figures 3 and 4a–c). Places like Kamorta, Daring Creek, Bada and Chhota Inak, Olinpow, Ohia, Manjula, Neecha-Tapu, Pilpillow,

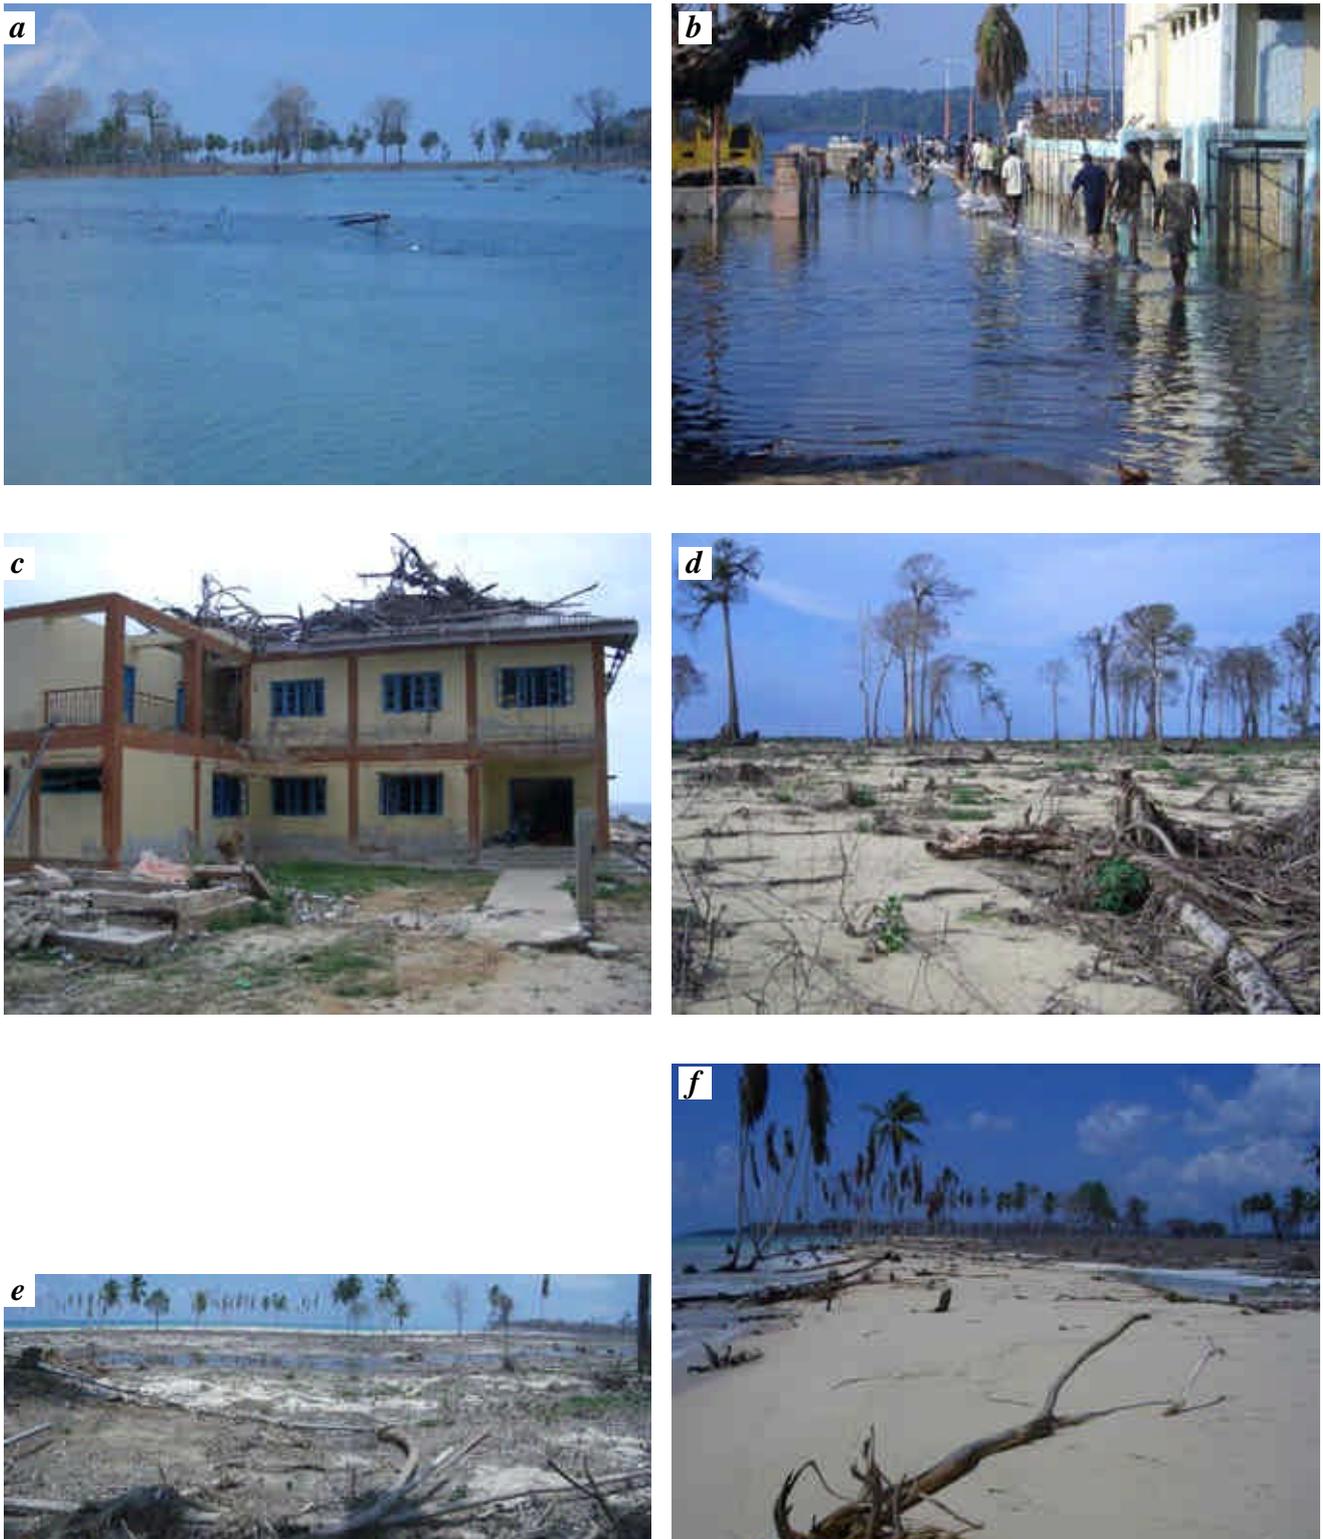
Figure 5. *a*, North and northeast facing view near the mouth of Daring Creek. From the foreground to the distant background the entire fertile flat land is submerged, but a narrow strip of land has remained. *b*, Photograph of a way to Kamorta jetty. Note the knee to waist-deep water during high tide, which indicates submergence of the coast by 1.5–1.75 m. *c*, A damaged school building built near the eastern bay shore in Kapanga village, Katchall. *d*, Photograph showing destructive effect of tsunami in the western coast of Katchall, Jhoola village, where dense coastal forests are changed to coastal deserts. *e*, Close view of sand bar bridge indicated by arrows in Figure 4 *b*. The flat and featureless Trinket land under subsidence is seen in the foreground, while Andaman Sea is seen in the background. Note uprooted trees and their stumps in the foreground which were large coconut farms and coastal forests. *f*, Close view of a narrow sandbar bridge connecting south and middle segments of Trinket Island. Note the devastated ground in the right and Andaman Sea in the left.

observed that the village Kapanga is entirely ruined leaving some walls of cement and concrete buildings made for hospital and school (Figure 5c). The east bay area has expanded twofold, where the old jetty has also been submerged. Jhoola, Jansin, Hitlat, Kalupong, Kamriak, Katahua, Miyayu and Chongipon villages located 0.5 to 1.0 km from the coast in the west and southwest have entirely vanished from the map. Jhoola in the eastern coast has been wiped out leaving a dreary ground of dilapidated, uprooted and dried trees (Figure 5d). The west bay swamp is engulfed and transgressed by nearly 4 km. Calculating the ground slope and aerial subsidence (transgression), the land of Katchall is found to be submerged by 2.0–2.5 m.

Trinket is one of the worst affected islands, where the land is reduced manifold, leaving only slender sandbars that are constantly being washed away and reconstructed by wave actions (Figures 3c and 5e). Taking the drowned houses and coconut trees as markers, it is inferred that land submergence in Trinket Island is found to be between 1.5 and 1.75 m. A natural sand bridge that connects the south and middle island is >3.2 km long and was 2.0 to 3.0 km wide before the earthquake (Figures 3c and 5f), which has been slandered by 20–30 m only.
