## Inundation characteristics and geomorphological impacts of December 2004 tsunami on Kerala coast

N. P. Kurian\*, Abilash P. Pillai, K. Rajith, B. T. Murali Krishnan and P. Kalaiarasan

Centre for Earth Science Studies, Thiruvananthapuram 695 031, India

**Inundation characteristics and geomorphological changes associated with the December 2004 tsunami along the Kerala coast are presented here based on post-tsunami surveys, tide data and beach profile measurements. Maximum inundation and damage was caused in the zones adjoining Kayamkulam inlet in southern Kerala. Arrival of the tsunami coincided with the high tide in this sector, resulting in maximum devastation. Impact of the tsunami was not felt in the afternoon in northern Kerala due to the ebb or low tide and maximum inundation along that sector is reported during midnight, coinciding with the next high tide. Beach profile measurements confirm erosional tendency of the tsunami, which deposited huge quantities of black sand**

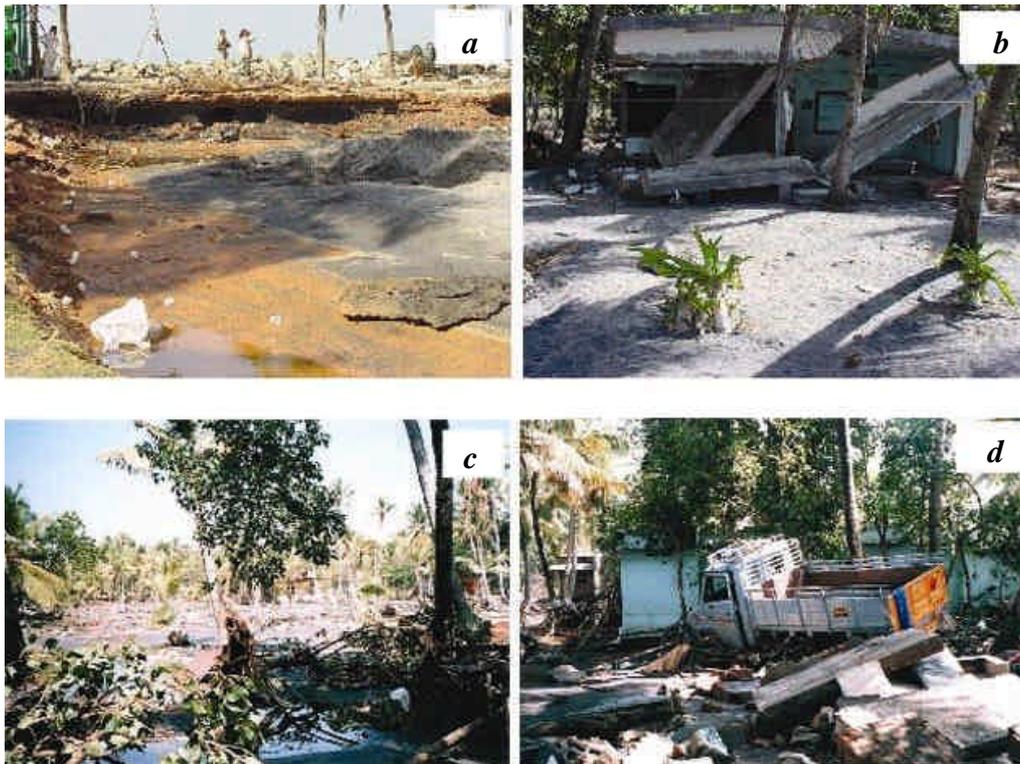
**Figure 3.** Total devastation caused by tsunami at Azhikkal region, south of Kayamkulam inlet. *a*, Deep scouring on the side of the coastal road; *b*, Damaged concrete house; *c*, Totally devastated fishermen colony and *d*, Remains of collapsed houses, including a lorry carried in.

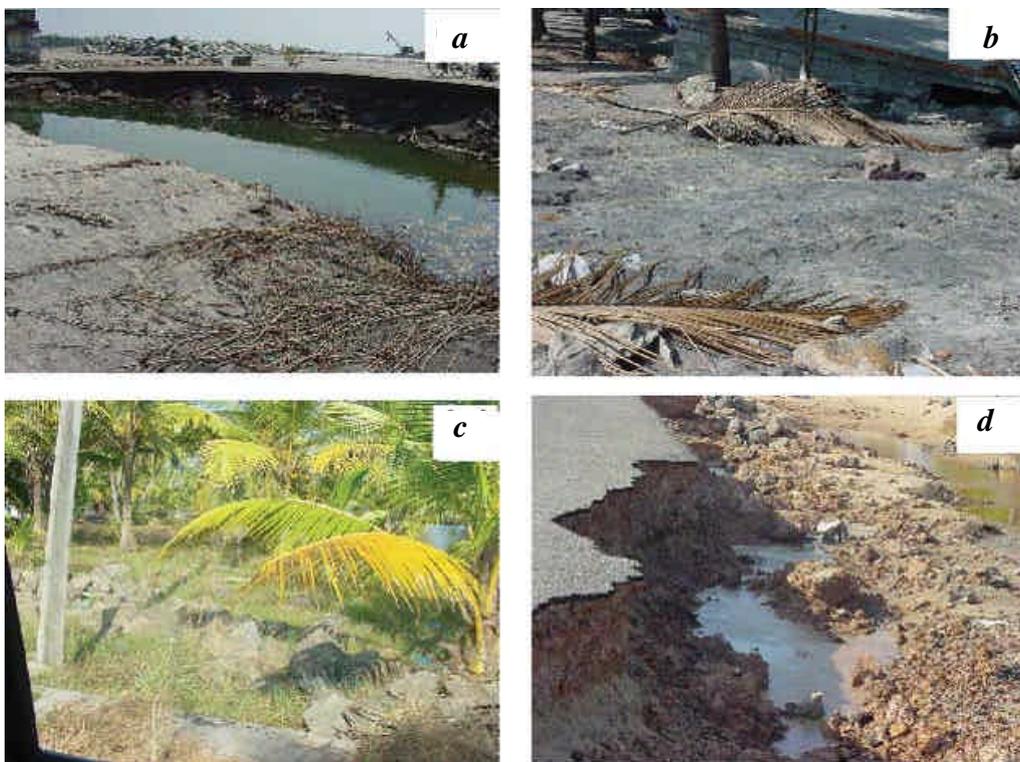
**Figure 4.** Devastation caused by tsunami at Valiazhikkal region, north of Kayamkulam inlet and Edavanakkad, north of Cochin. *a*, Deep trench formed close to the coastal road immediately to the north of Kayamkulam inlet; *b*, Roof of a newly constructed house grounded due to wall collapse; *c*, Boulders of sea walls thrown inland at Edavanakkad and *d*, Deep trench formed close to the coastal road at Edavanakkad.

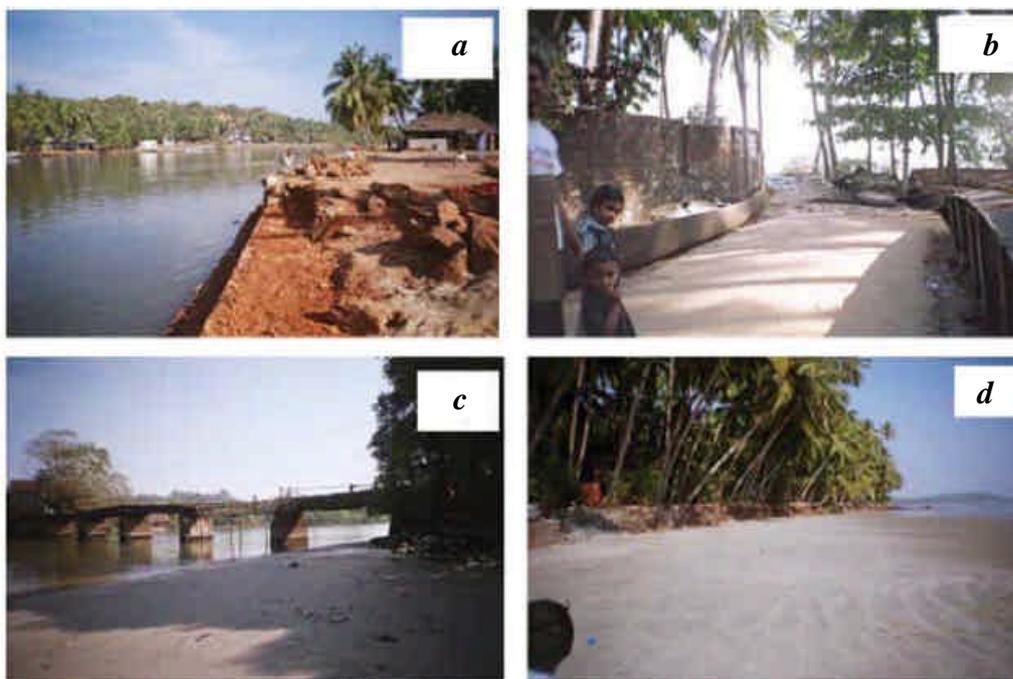
**Figure 5.** Examples of tsunami inundation from northern Kerala. *a*, Collapsed embankment at Choottad, Cannannore; *b*, Country boats thrown inland at Kadalur point, Calicut; *c*, Damaged railway footbridge at Thalassery and *d*, Collapsed laterite banks at Kadalur point, Calicut.

deaths were reported in addition to damage and loss of fishing gadgets. In the zone north of Anthakaranazhi up to Cochin inlet, there was no significant inundation or damage. However, at Puthuvype, just north of Cochin, many shops arranged for a beach carnival were damaged. Further north, in the Edavanakkad region, inundation was high causing widespread damage in the area (Figure 4 *c, d*). Many houses were completely damaged and five people were killed, a number that would have gone up, had the area been more densely populated. Deep pits were formed along eastern side of the coastal road. Huge boulders of sea wall of this area were thrown far inland by the tsunami. The impact clearly shows that even the sea wall cannot protect a coast from the tsunami. There was a reduction in the inundation further north, till Munambam inlet, where the waves entered upstream up to about 500 m and flooded up to a level of 2.5 m in the eastern parts, causing extensive damage to houses. Further north, in the Ponnani, Calicut, Cannannore and Kasaragode coasts, inundation was low. However, the flood waters caused some damage at a few locations (Figure 5) along the northern Kerala coast.
